CIRCULAR 62-AN/57

AIRCRAFT ACCIDENT DIGEST

No. 11

Trans World Airlines, Lockheed Super Constellation 1649-A, N 7313C, accident in the vicinity of Olgiate Olona, Varese Province, Italy on 26 June 1959. This summary is based on the English translation of the final report of the Board of Inquiry, appointed on instructions from the Ministry of Defence, Republic of Italy, as released in November 1960 as a Civil Aeronautics Board (USA) Aircraft Accident Report, File No. 1-0045.

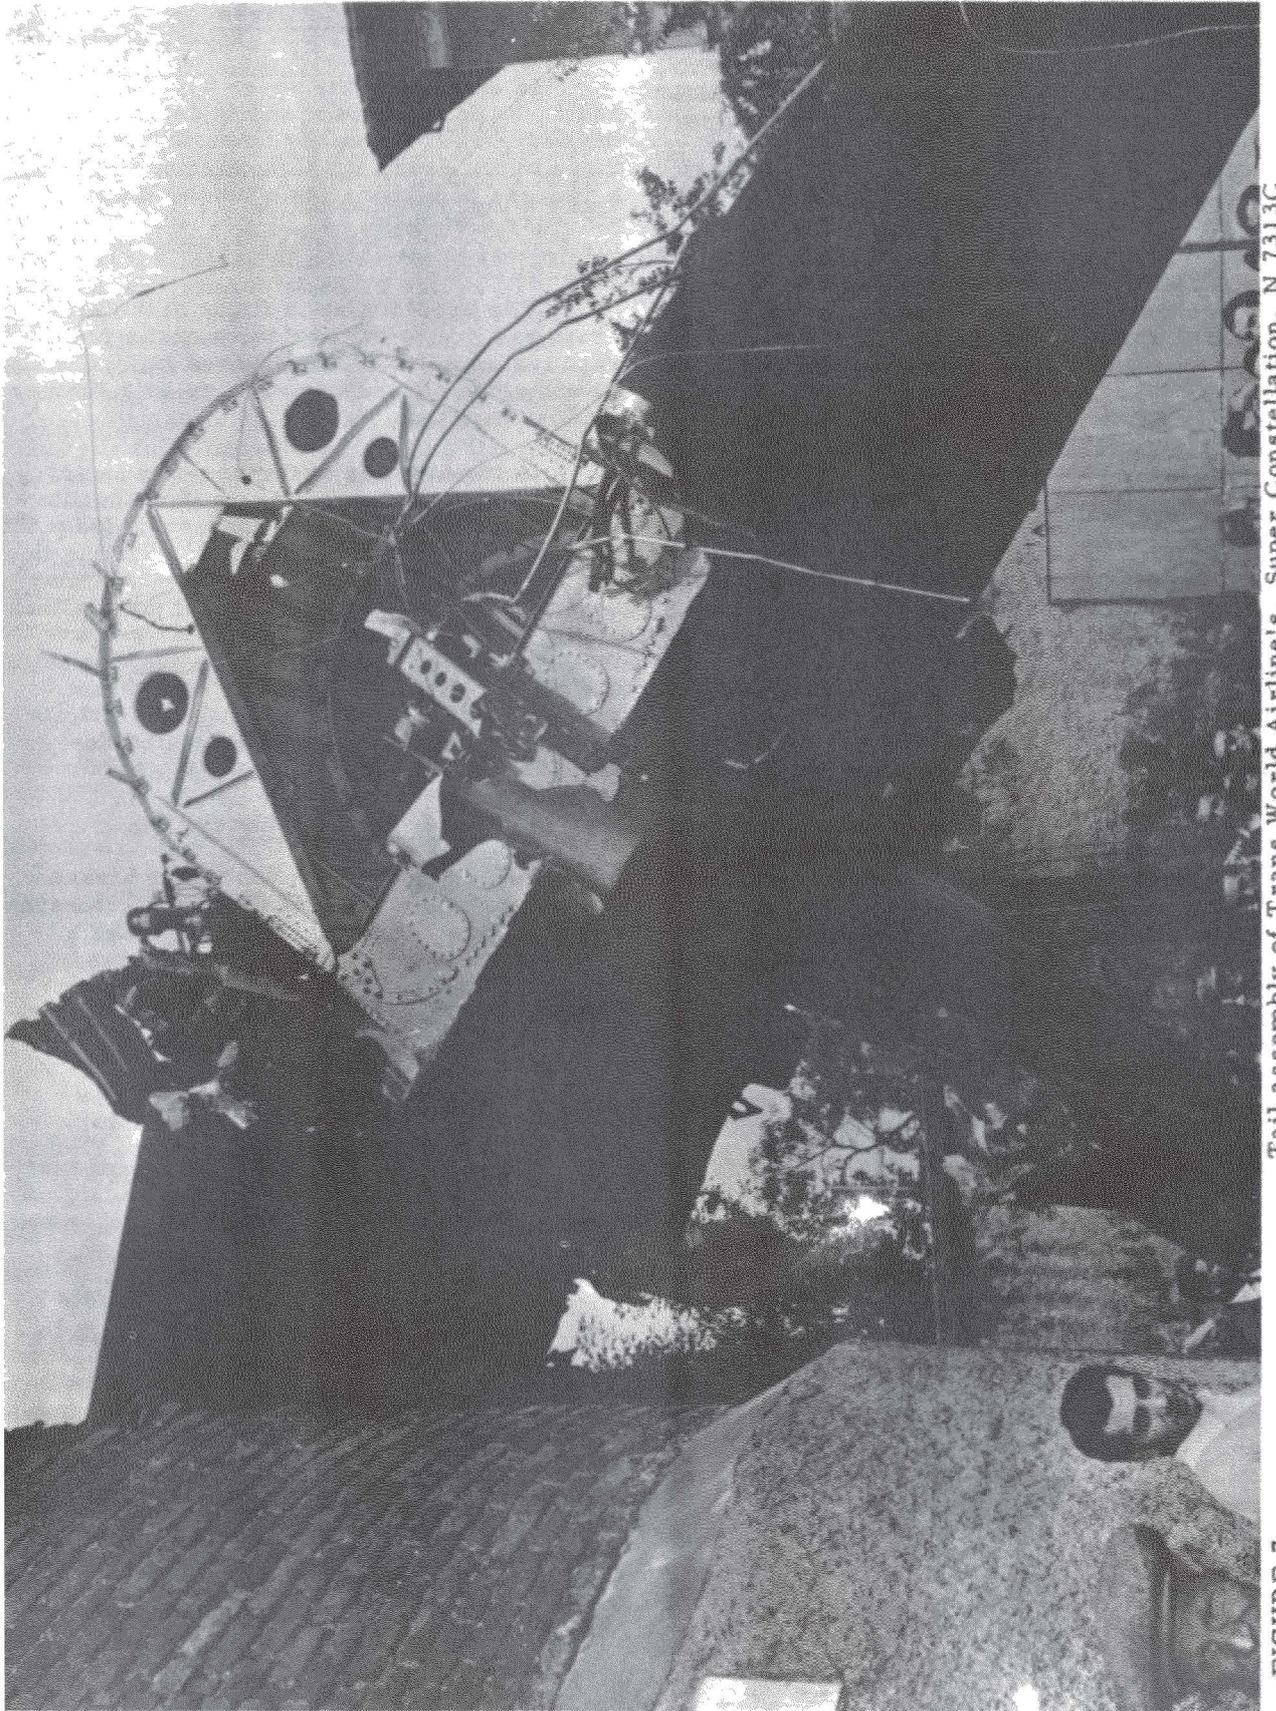
FIGURE 7

6. The entire tail assembly became separated from the plane in flight at a point beyond the pressurization bulkhead and fell close by a fencing wall about 450 m south of the main wreckage, and was considerably damaged. Five pieces of the two elevators, the lower part of the left rudder and part of the terminal stern cone and fairing were found distant from the tail assembly, indicating that these parts broke off while the aircraft was still in the air.

Examination of the breakage area of the tail assembly failed to disclose any trace of metal fatigue and showed that the assembly became separated from the end of the fuselage as a result of static overloads, directed to the left and downwards. Evidence showed that the assembly was structurally in its proper position when, during flight, a fire broke out on the front part of the aircraft and enveloped the tail assembly from its right side.

Tail assembly of Trans World Airline's, Super Constellation, N 7313C which crashed in Varese Province, Italy, on 26 June 1959.
